A WATER QUALITY STUDY OF SANDY LAKE MANITOBA

A Project Report
Presented to
The Department of Civil Engineering
The Faculty of Engineering
The University of Manitoba

by
Nancy Scott
October 29, 1992

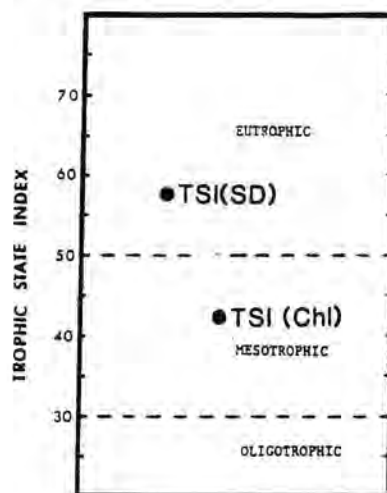
Figure 6: Carlson's Trophic State Index

The values obtained from these computations were then placed on Carlson's Index (Figure 6).

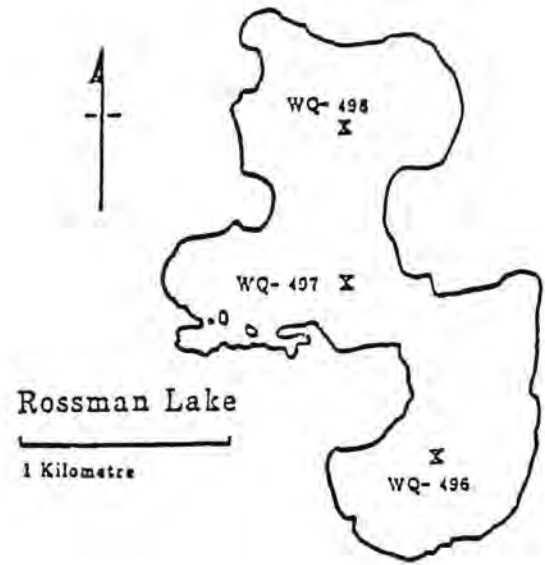
Figure 1: Water quality stations on Killarney, Wahtoppanah, Rossman and Sandy Lakes.
